PETER HUGHES
PROPERTY INSPECTIONS

Defect Inspection Report
To AS4349.0-2007 Inspection of Buildings General Requirements

Property Address: 1 & 2 36 Carroll St Gunnedah NSW 2380

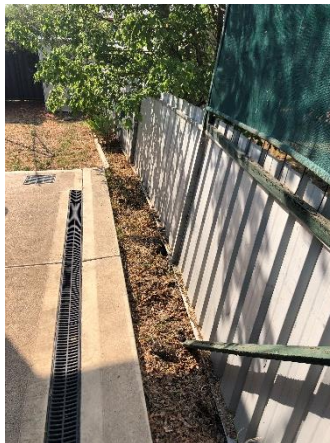
Garden Sheds and Fences: Defects/Safety Hazards found were movement can be seen in back fence. Consult with a licensed contractor for repair.

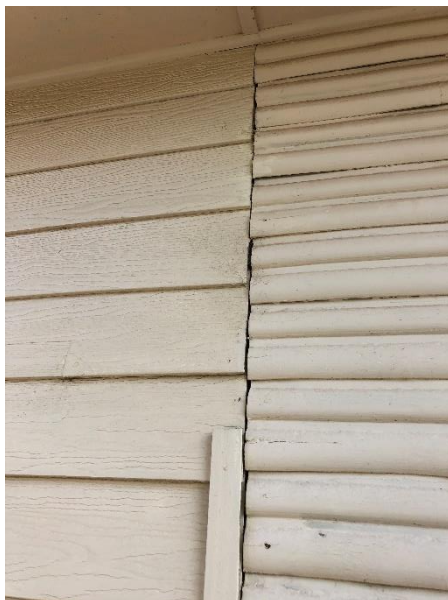
Walls: Defects/Safety Hazards found were join in cladding to be sealed to avoid waterproofing defects. Consult with a licensed contractor for repair.

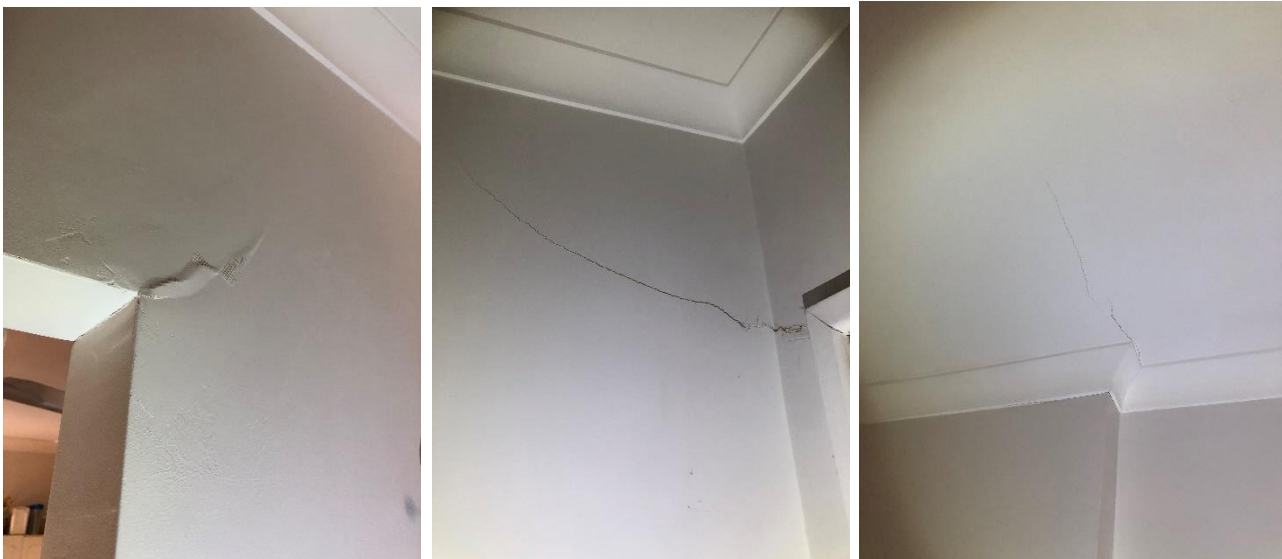
Lounge Room: Defects/Safety Hazards found were cracking can be seen in the wall lining and ceiling sheeting.

Consult with a licensed plasterer for repair of cracking and damage in wall lining and ceiling

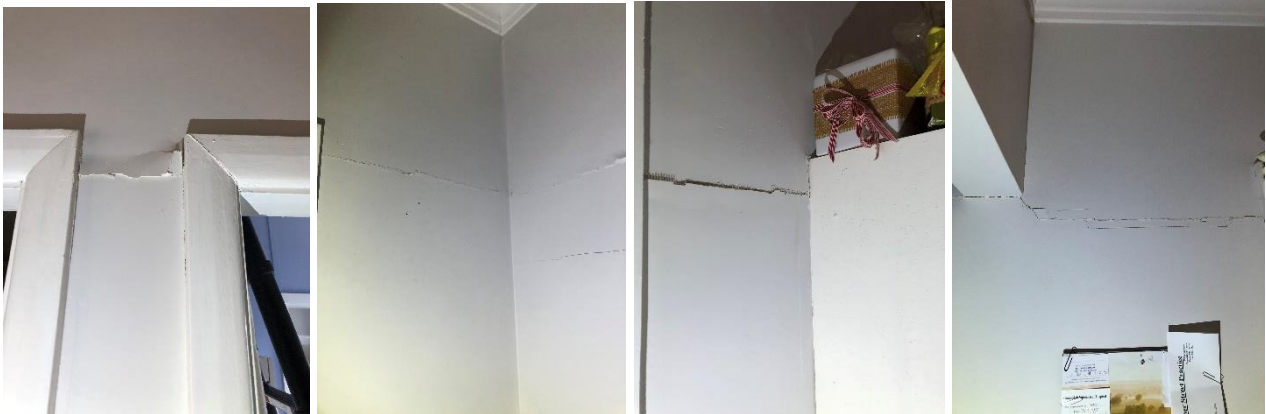
Kitchen / Dining: Defects/Safety Hazards found were cracking in the wall lining. Damage to lino flooring. Consult with a licensed contractor for repair.

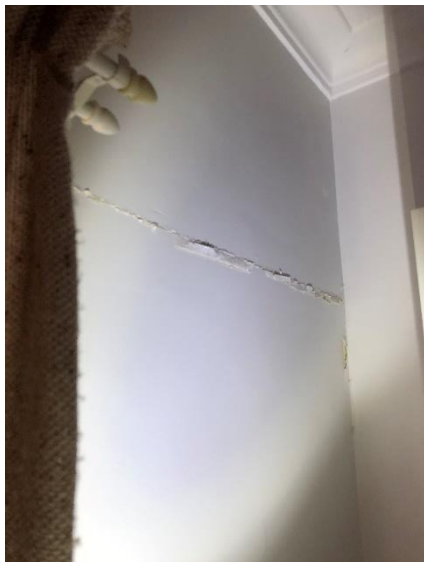
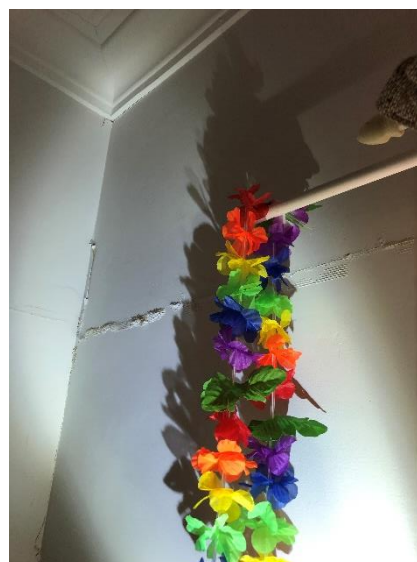
Bedroom 1: Defects/Safety Hazards found were cracking in the wall lining along sheet joins around wall.

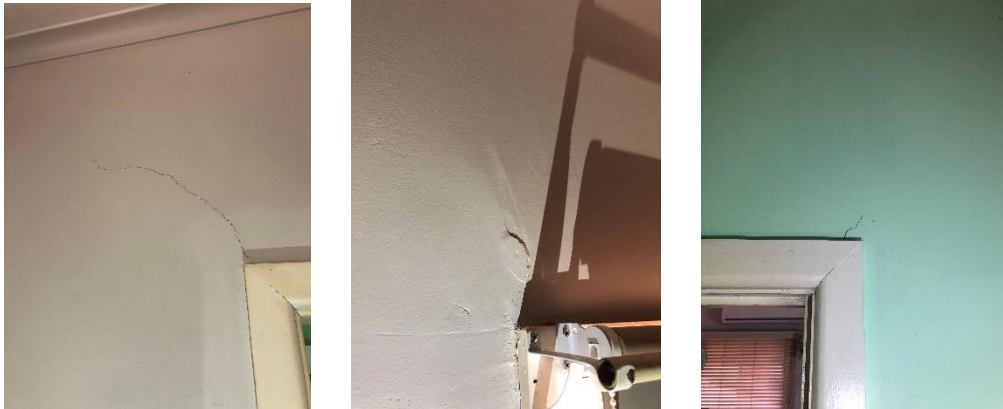
Lounge Room: Defects/Safety Hazards found were cracking in wall lining.

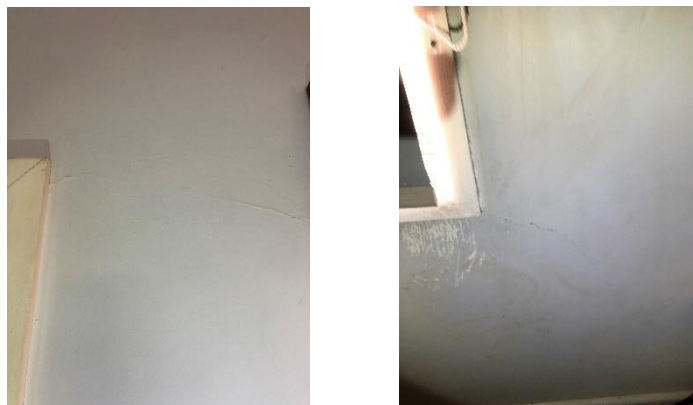
Bedroom 1: Defects/Safety Hazards found were cracking can be seen in the wall lining around window.

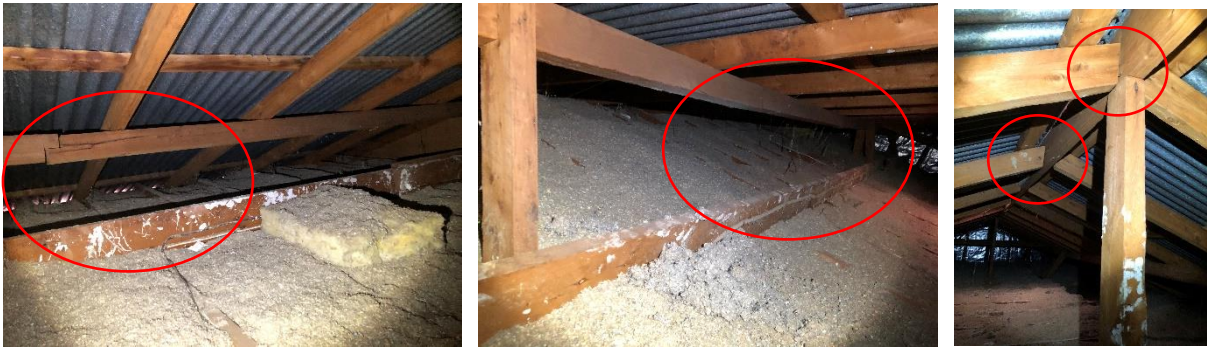
Roof Framing: Defects/Safety Hazards found were rafters seen pulling away from ridge. Under purlin beam supported by struts on one end only causing it to sag at other end. To ensure structural integrity is not compromised consult with a licensed builder for recommendations.

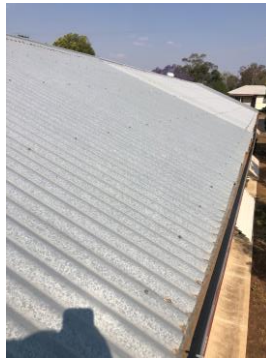
Roof Flashings: Defects/Safety Hazards found were three screws along bottom of roof sheets causing movement in iron. Consult with a licensed roof plumber to ensure this complies with relevant Australian Standards.

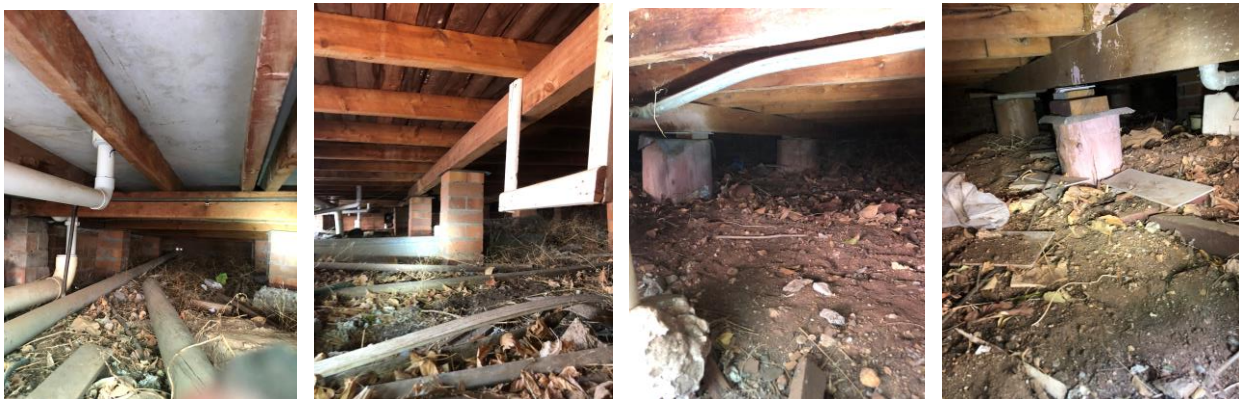
Piers/Posts/Supports: Defects/Safety Hazards found were movement can be seen in piers. non loadbearing piers found. Space between pier and bearer causes movement that can lead to cracking and other signs of structural damage. Consult with a licensed builder for repair.
