PETER HUGHES
PROPERTY INSPECTIONS

Defect Inspection Report
To AS4349.0-2007 Inspection of Buildings General Requirements

Property Address: 1 & 2 36 Carroll St Gunnedah NSW 2380

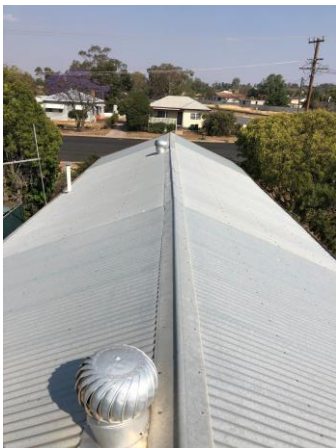
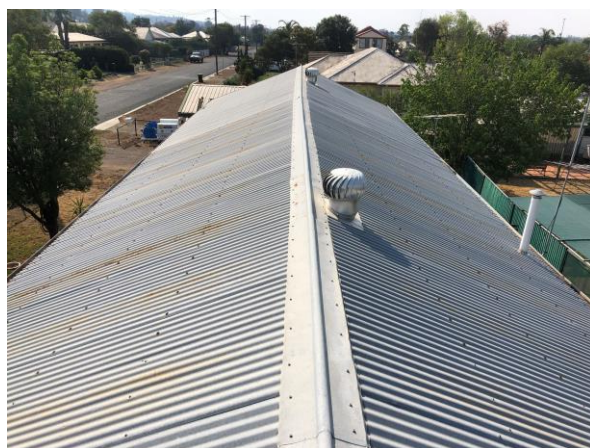
Roof Flashings: Defects/Safety Hazards found were three screws along bottom of roof sheets causing movement in iron. Consult with a licensed roof plumber to ensure this complies with relevant Australian Standards.
